Technical guidance sheet 2.1

Physical protection of battery systems

Solar
Victoria

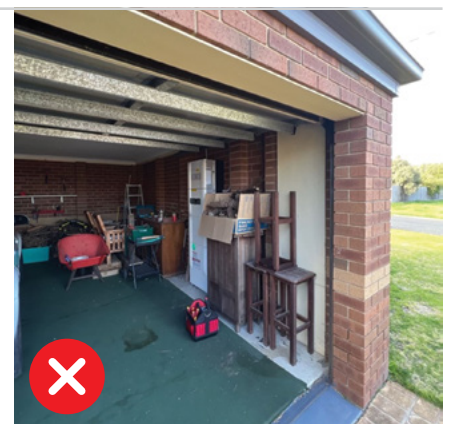
Figure 1.3:
A vehicle could enter into this space, meaning that fixed vehicle mechanical protection would be required regardless of any non-fixed objects that could be installed.

Additionally, if the area in question could allow a vehicle to enter the space (regardless of the homeowner's non-fixed objects) suitable fixed vehicle mechanical protection must be installed.

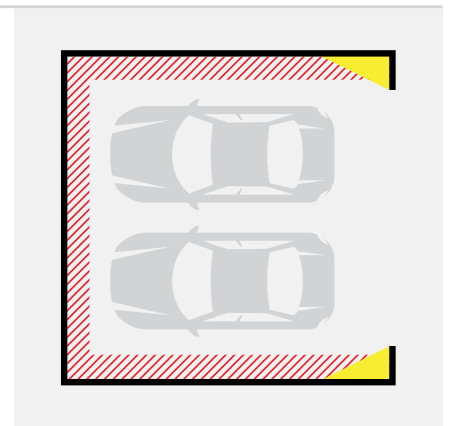
Figure 2.1:

Diagram demonstrating mechanical protection afforded by garage pillar walls for a standard double garage 6m x 6m and standard single garage 4m x 6m.

Area requiring additional mechanical protection (such as a bollard)

Area deemed protected by the garage pillar, not requiring additional protection

Where the battery system is located in the front corner of a typical 6m long garage and is protected by a solid front pillar or wall, it is reasonable to expect vehicle impact could not occur. A bollard therefore may not be required in this location (see Fig 2.1).

Note: As a guide, the protected area is calculated at a ratio 1:2.5 i.e. a 500 mm garage pillar would allow an area of 1250mm protection along the wall.

If the battery system is set further back than the area afforded protection by the garage pillar, additional protection may be required.

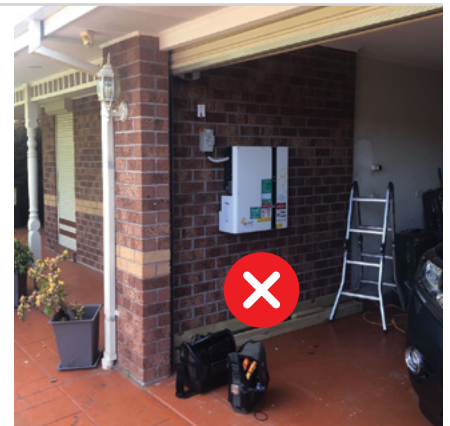
Figure 2.2:

The battery is too far away from the front corner of the garage and would require additional mechanical protection to be compliant.

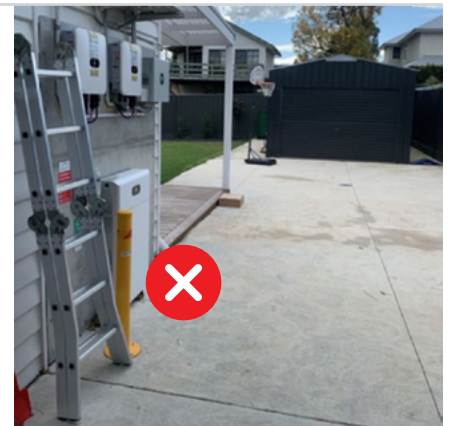
Figure 3.2:
As noted in Figure 3.1, there is adequate area for a car to drive beyond the edge of the battery, this requires additional mechanical protection be installed on the trailing edge of the battery.

As such, an additional bollard would need to be installed near the trailing edge of the battery system observed in this example to ensure adequate mechanical protection from vehicle strike.

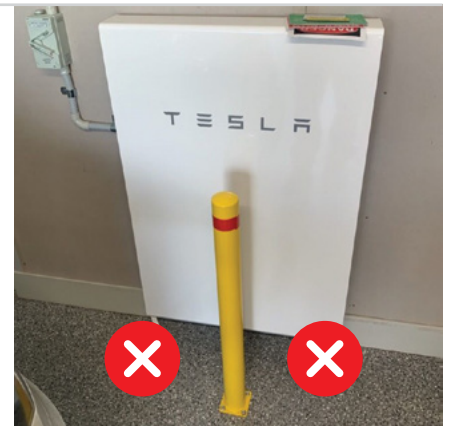
Figure 4.1:

The following system provides no protection against a car-strike on the left or right side of the battery and is therefore not compliant.

In this example, a bollard has been installed in front of the battery system to protect against vehicle strike.

The centre placed bollard is inadequate to protect against potential vehicle strikes on the left and right-hand sides of the battery. Suggested compliant protection for this example may include the installation of two additional bollards (either side of the battery) or a U-shaped bollard system installed around the front of the battery system.

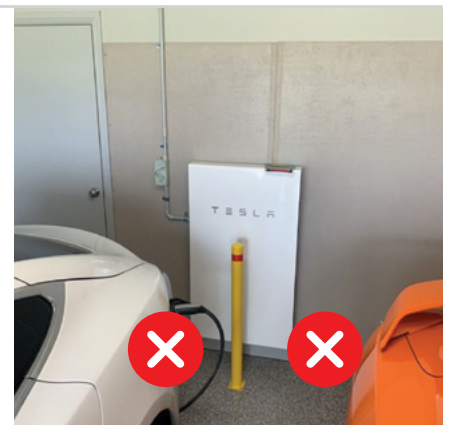
Figure 4.2:

The presence of two cars highlights the possibility of a car strike despite the attempt to provide mechanical protection with the bollard.

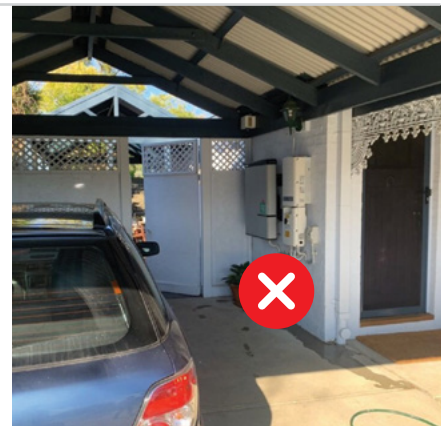
Figure 5.2:

Despite being above the ground, this battery is clearly within the range of the blue car shown in the image, particularly if reversing into the driveway. As such, further mechanical protection is necessary.

As such, additional bollards may be required to be installed in all three of these examples to provide mechanical protection against vehicle strikes.

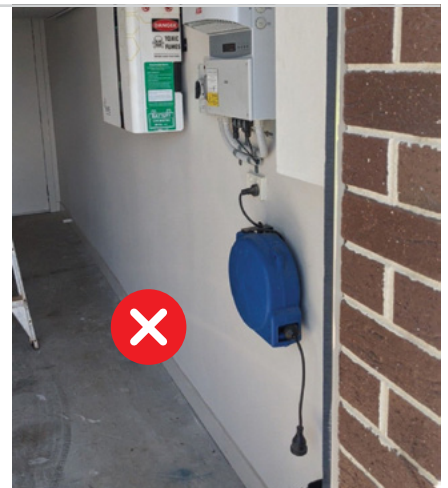
Figure 5.3:

Similar to Figure 5.1, this is not high enough to be out of the range of vans or large cars such as SUVs.

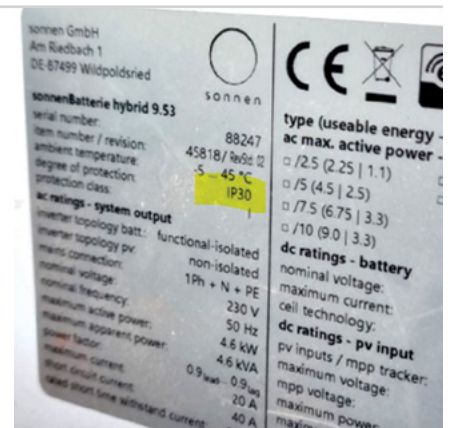
Figure 7.1:

The highlighted yellow text (the label on the front of the battery) indicates an ingress protection rating of IP30 – meaning there is no protection against the ingress of water provided by the battery's enclosure.

In these examples, a battery system has been installed with an ingress protection rating of IP30. This means there is no water ingress protection provided by the battery enclosure.

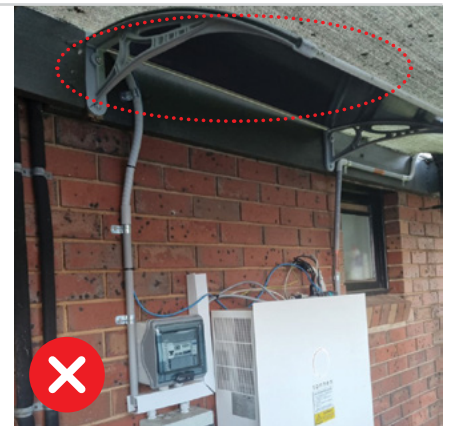
Figure 7.2:

Due to the IP30 rating, the whole battery is required to be within 30 degrees of a waterproof overhang or veranda. This is not occurring in this image – the veranda is too small.

The installer has made an attempt at protecting the battery system by installing a small veranda/overhang above the battery.

As the electrical equipment has no water ingress protection rating, in this example the entire piece of equipment would need to be located within 30 degrees of an adequately waterproofed veranda or overhang (as per AS/NZS 3000:2018 Clause 4.1.3).

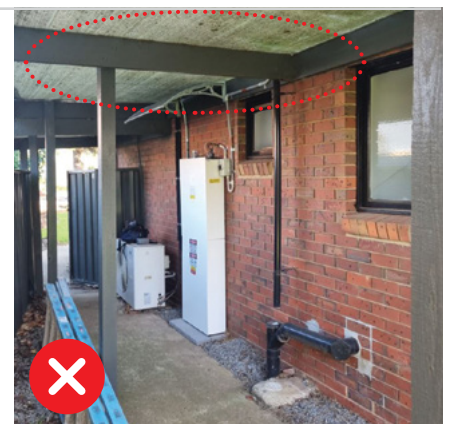
Figure 7.3:

The large green roof above the battery system is made from shade cloth, which is not waterproof and does not provide appropriate water ingress protection to the battery system.

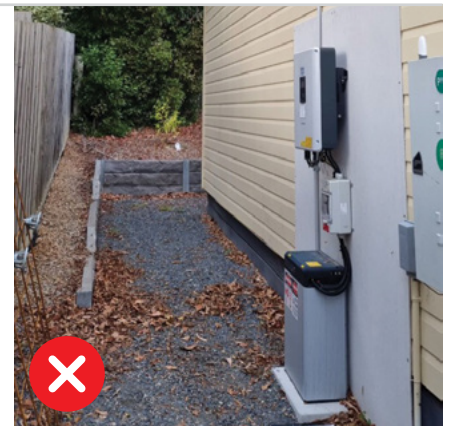
Figure 8a:

This system has no protection from direct sunlight or moisture, making this system non-compliant with manufacturer's instructions.

These are the manufacturer's installation location requirements for the battery systems shown in Figures 8a and 8b. In particular, the 'notice' highlights the requirement to avoid exposing battery to direct sunlight and moisture.

The RESU battery pack is rated at IP55 and thus can be installed outdoors as well as indoors. However, if installed outdoors, do not allow the battery pack to be exposed to direct sunlight and moisture.

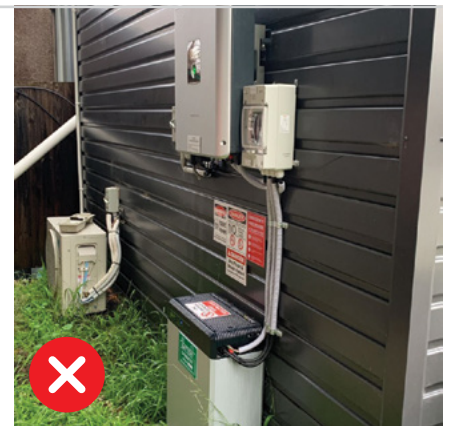
Figure 8b:

Like the system in 8b, no protection from sunlight or moisture has been provided for this battery system.

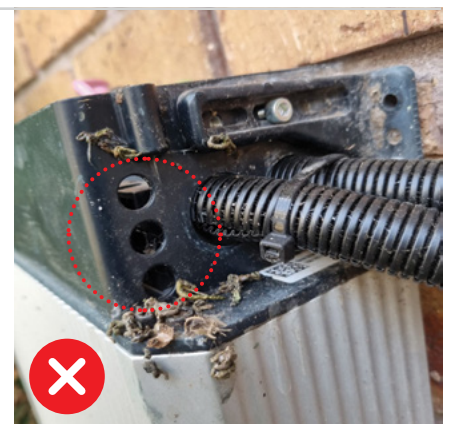
Figure 9c:

In this example the unused cable entries on the left of the battery system have not been sealed to prevent the ingress of flora and fauna.

Most manufacturers will supply additional bungs or sealing kits for unused cable entry points into their battery systems.

It is important these unused cable entry points are correctly sealed to prevent the entry of vermin and also to maintain the manufacturer's Ingress Protection (IP) ratings.
